**SAAD DAHLEB UNIVERSITY - BLIDA**

**MASTER'S THESIS IN CIVIL ENGINEERING**

**SEISMIC FRAGILITY CURVES OF SCHOOL BUILDINGS IN  
ALGERIA: CASE STUDY OF THE GREAT BLIDA**

The goal of this study is to analyze the seismic behavior of school buildings in the area of Blida.

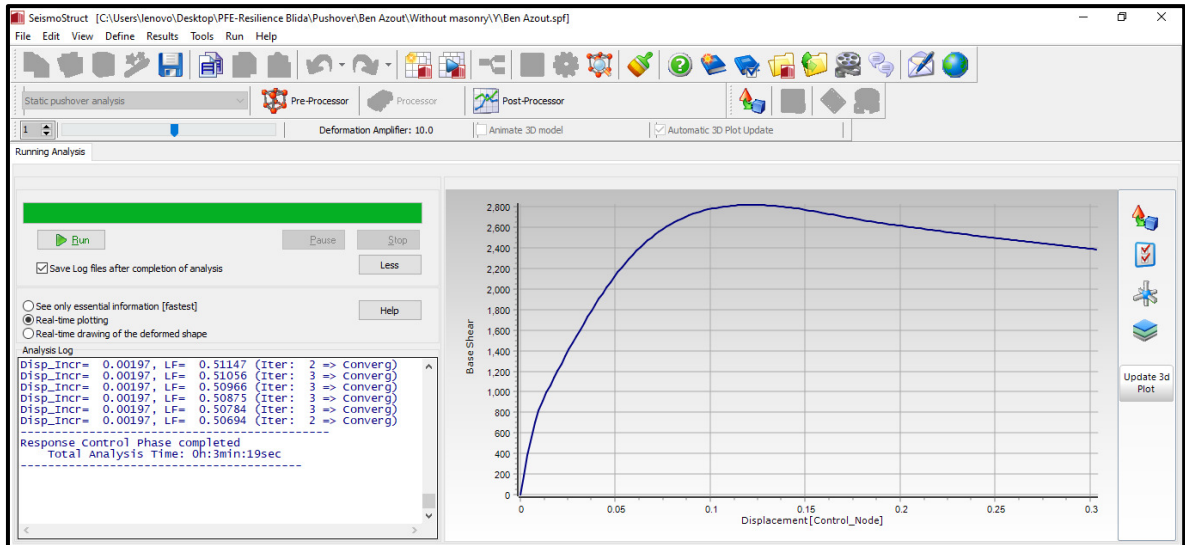
**Figure I.12:** Pushover analysis performed by SeismoStruct.

Static pushover analysis (Fig I.12) is an analysis method where the structure is subjected to both gravity loading and a displacement controlled lateral load pattern which continuously increase by the program until an ultimate condition is reached.

The target condition chosen in this analysis is the collapse prevention limit state (Maximum drift = 4%):

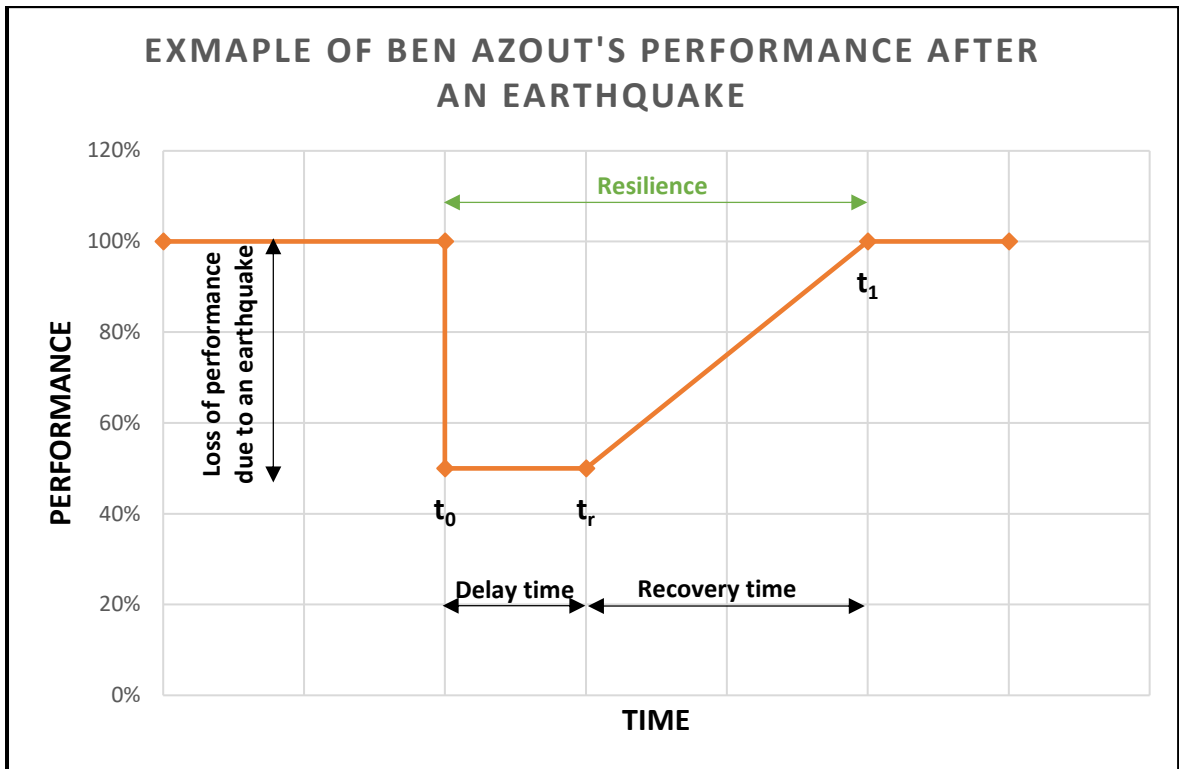
**Figure I.20:** Performance of Ben Azout school after an earthquake.

Since schools are the main focus of this study, let us consider the school of Ben Azout as example, the performance  $P(t)$  of any school can be measured at any time by the number of students it can serve. For this specific school that number is 250 students, let us call this the optimal performance, this performance can range from 250 students (100%) where there's no degradation in service to 0 student (0%) where no service is available. If an earthquake occurred at time  $t_0$ , destroying several classrooms, resulting in half the students having no place to study, the performance of this school is immediately reduced from 250 students (100%) to 125 students (50%), as indicated in (Fig I.20), after short delay  $t_r$  for preparation, the repairs starts until time  $t_1$  when it is completely repaired.

Hence, the school earthquake loss of resilience  $R$ , with respect to that specific earthquake, can be measured by the size of the expected degradation in performance, over time (time to recovery). Mathematically, it can be defined by:

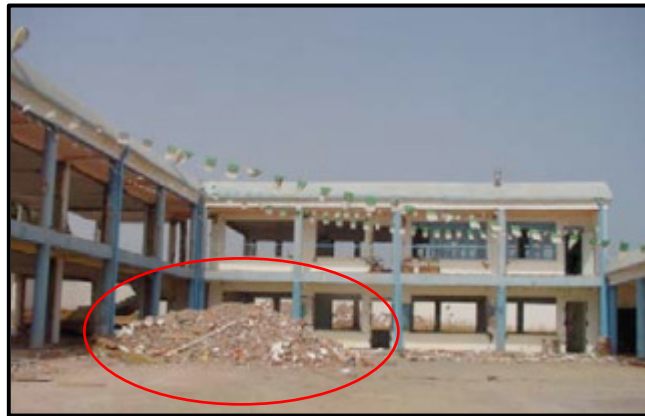
**Figure II.6:** Masonry infill damage during Boumerdes earthquake.

- **Rupture of stair cases.**
- **Damage in masonry infill** (Fig II.6)

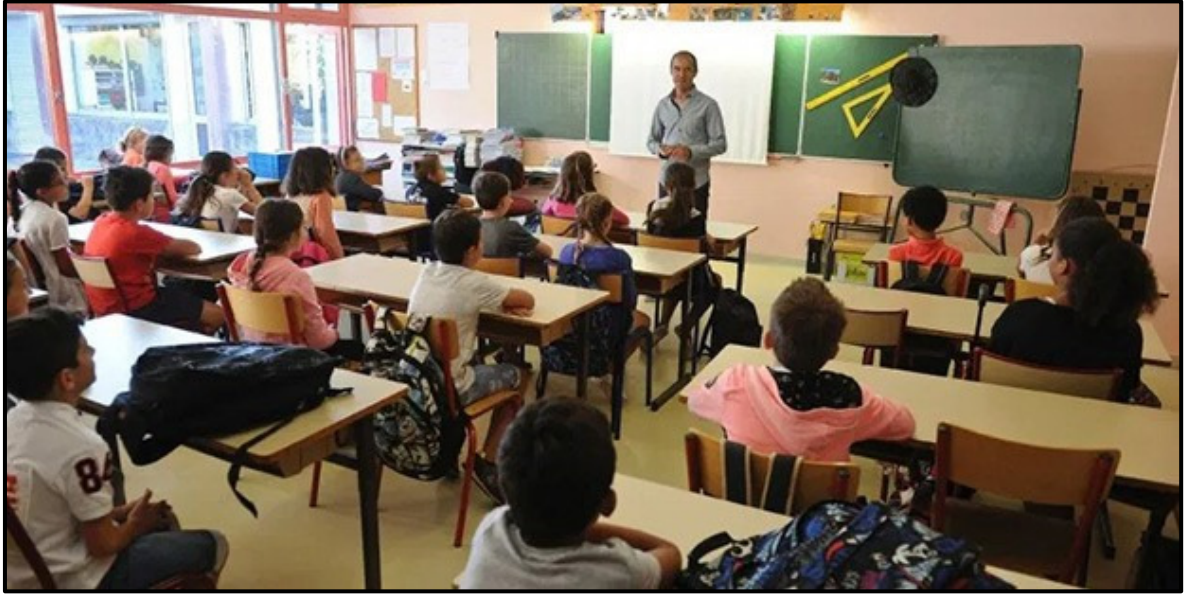
**Figure II.7:** Lack of interior support inside classrooms.

The need to accommodate the large number of pupils per teacher and to have unobscured line of sight leads to making large classes without the necessary interior support (Fig II.7).

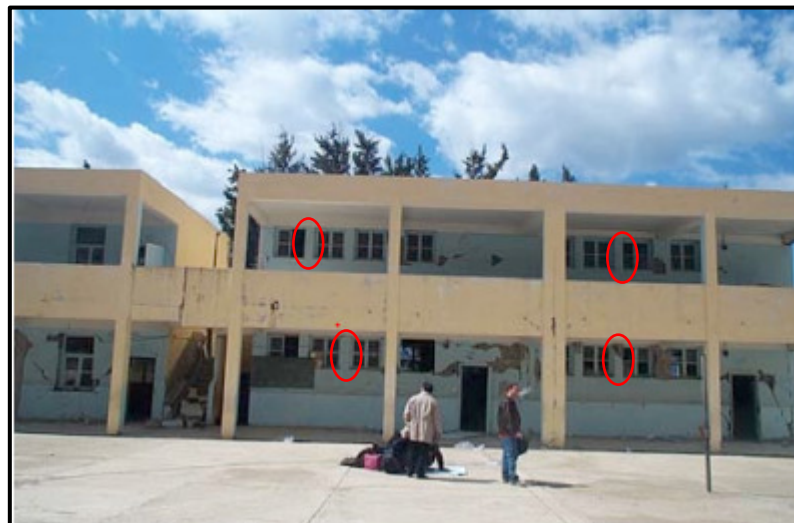
**Figure II.8:** Short columns effect in Algerian schools.

Additionally, having the need to provide cross-ventilation and natural light lead schools to having large windows, that create lot vulnerabilities; Many concrete frame buildings have stiff partial-height masonry walls below the windows, which create “short or captive columns” (Fig II.8) failure above the wall which fail in shear, making it is one of the most common causes of seismic damage according to the earthquakes reports around the world.

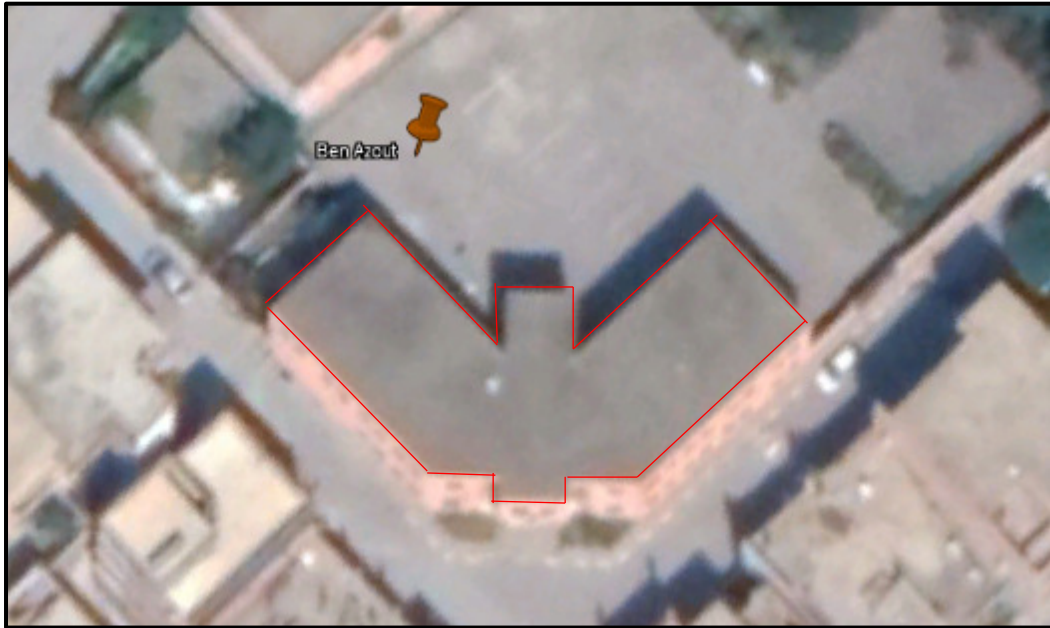
**Figure II.9:** Irregular layout of some schools in Great Blida.

the buildings that relies on walls for seismic resilience cause the long span of roofs and floors allow the walls to move more which can cause the roof or floor to pull apart and collapse which did happen during the Boumerdes earthquake.

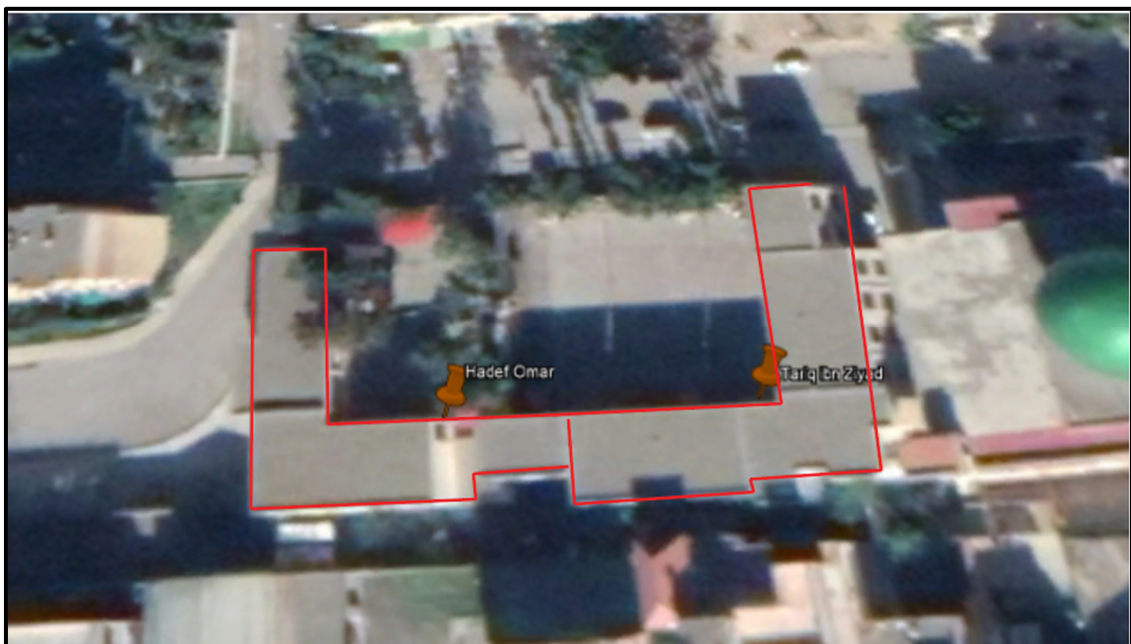
**Figure II.10:** The L shaped design commonly used in Algerian schools.

Many of the schools in Algeria (especially before Boumerdes earthquake) share the same design; due to jurisdictions using a standard building design for multiple schools (the common L shaped school design for example) (Fig II.10) to reduce cost and improve the efficiency of construction, but on the other hand **if** the standard design have major seismic weakness, then those weakness will appear in the many schools that share or have similar design.

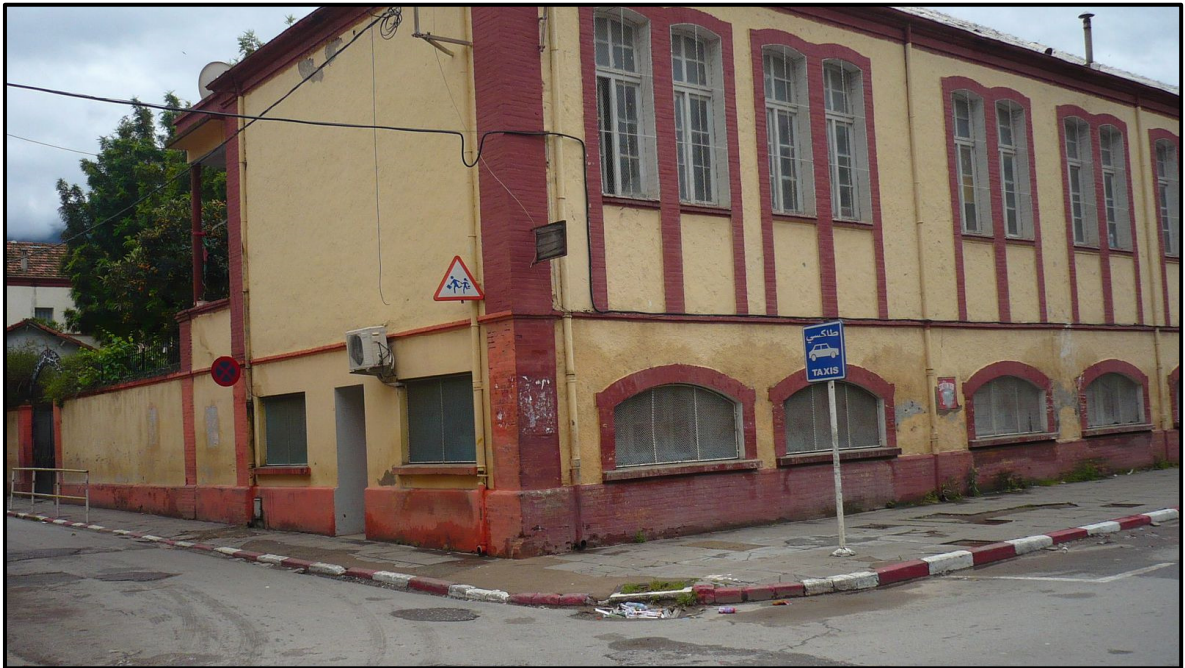
**Figure II.18:** Ahmed Abed primary school (Masonry building).

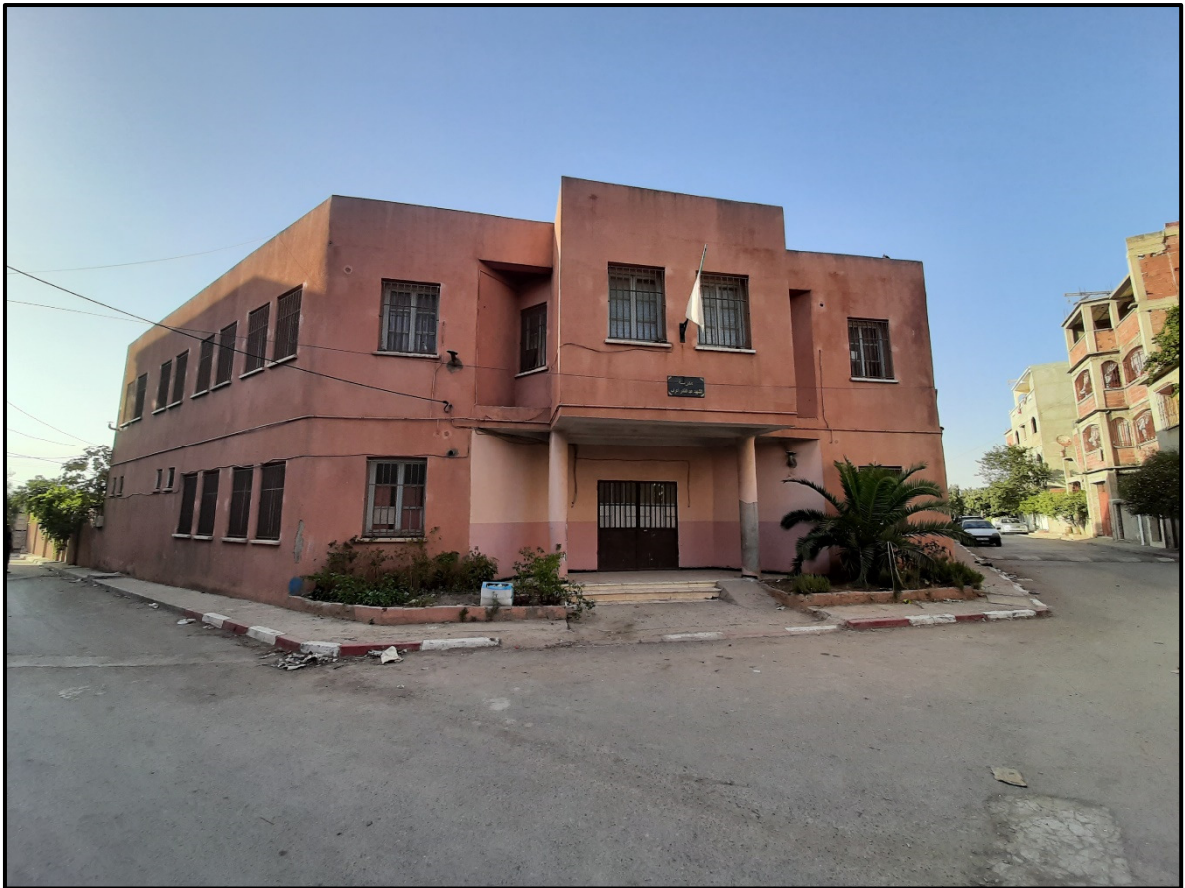
**Figure II.19:** Ben Azout primary school (Moment-resisting frame system).

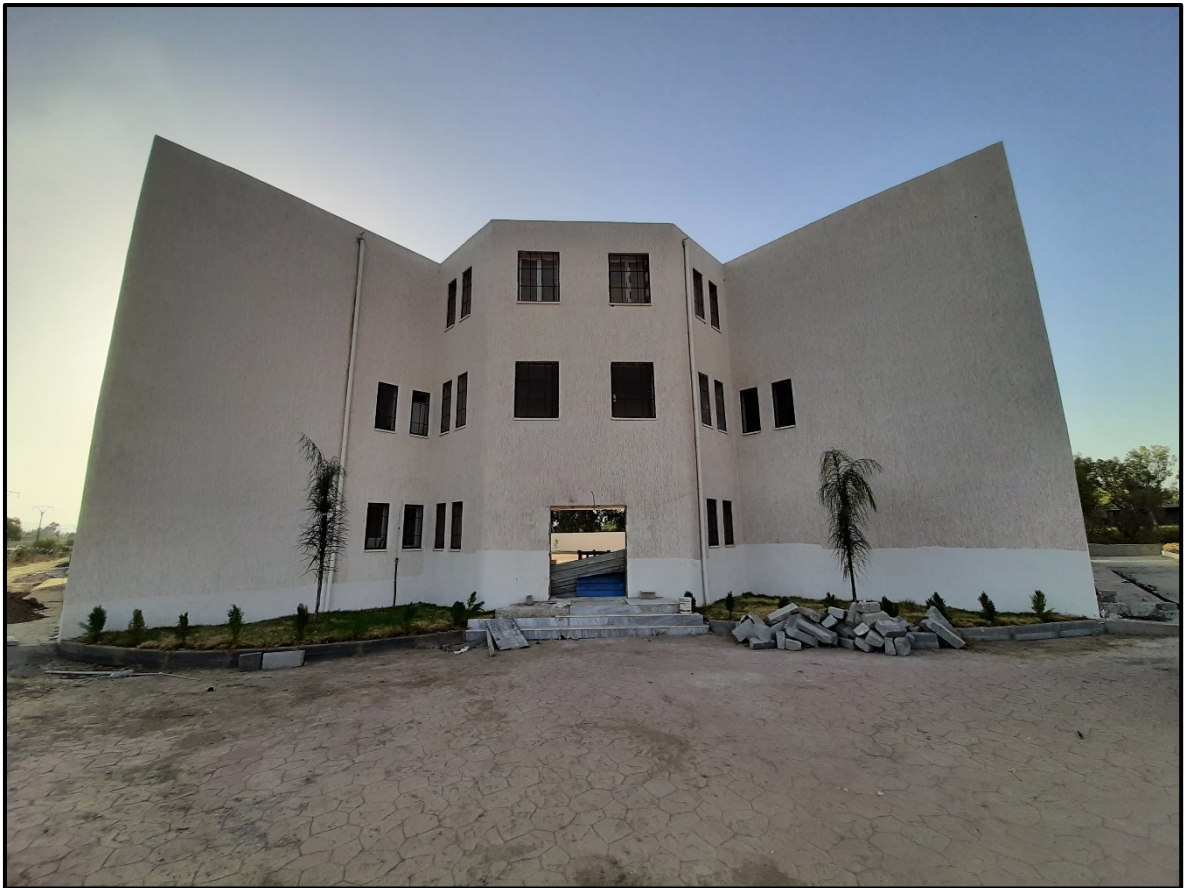
**Figure II.20:** A middle school under construction (RC walls system).

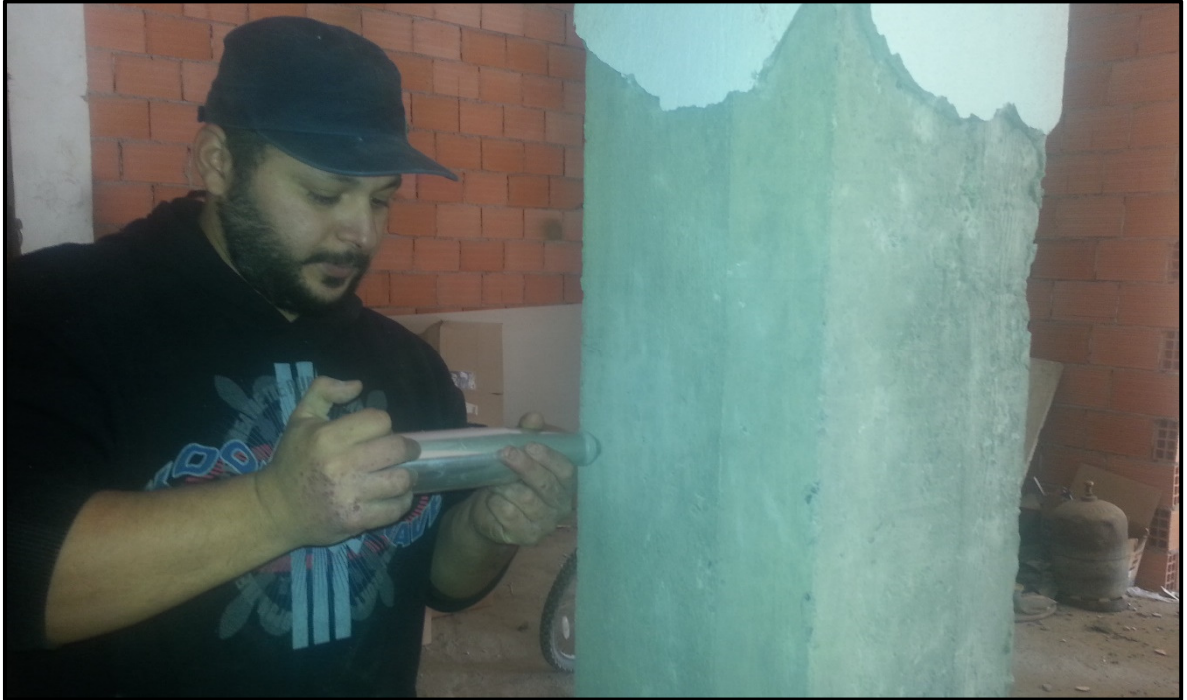
**Figure II.29:** Measuring the compressive strength of concrete using the concrete hammer test.

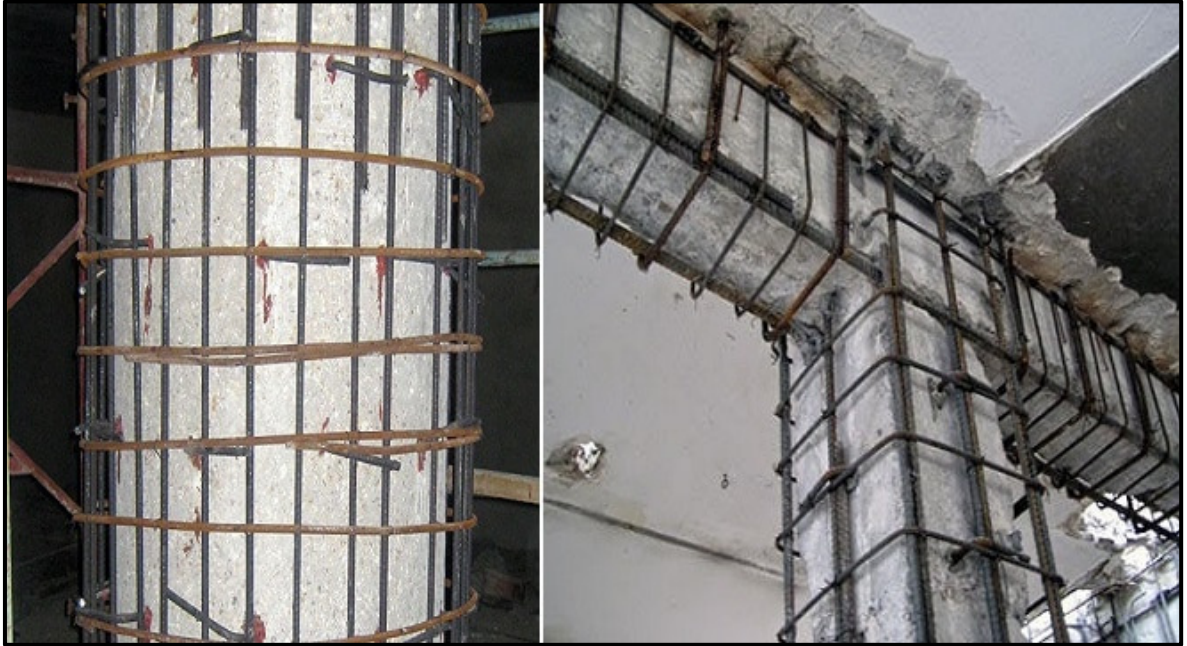
**Figure II.32:** Examples of column and beam jacketing.

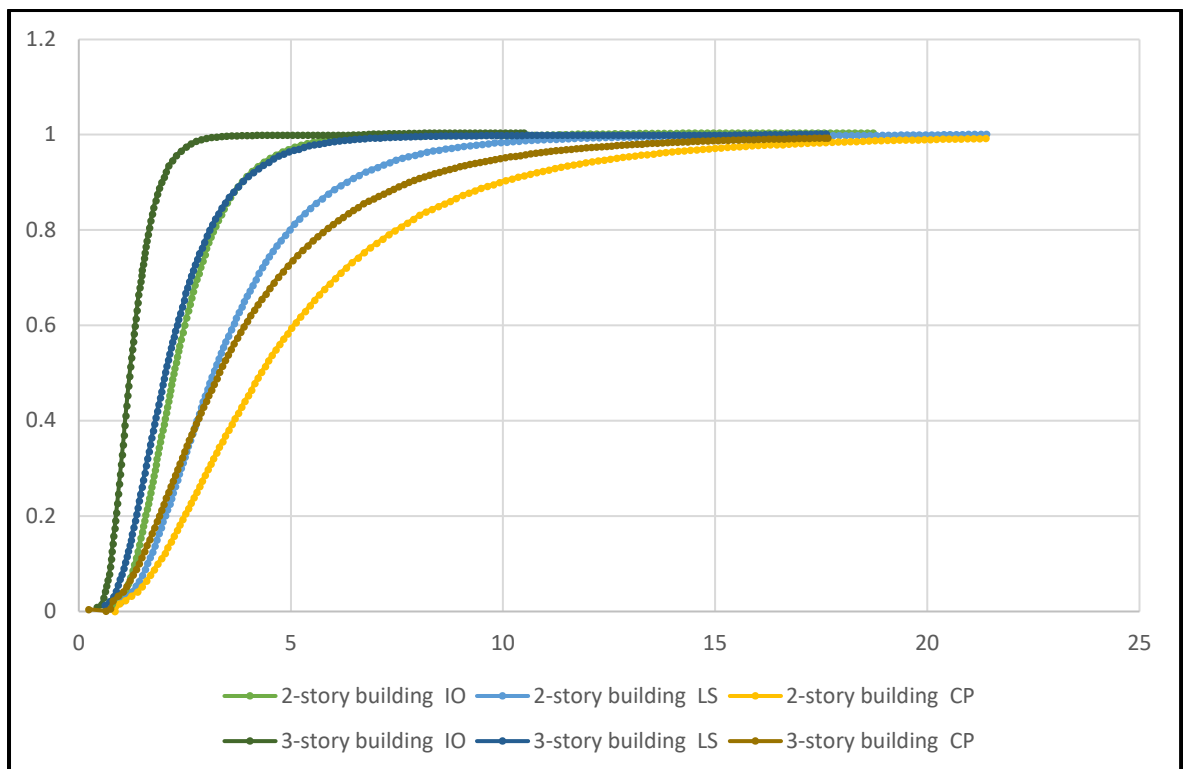
Figure V.26: Collapse fragility curves comparison between 2-story and 3-story buildings.
