Thesis of the master degree in architecture

Option: Technology, Environment, and Architecture

**Preserving the past, powering the future, energetic
rehabilitation of a historical building in Blida – Douirette**

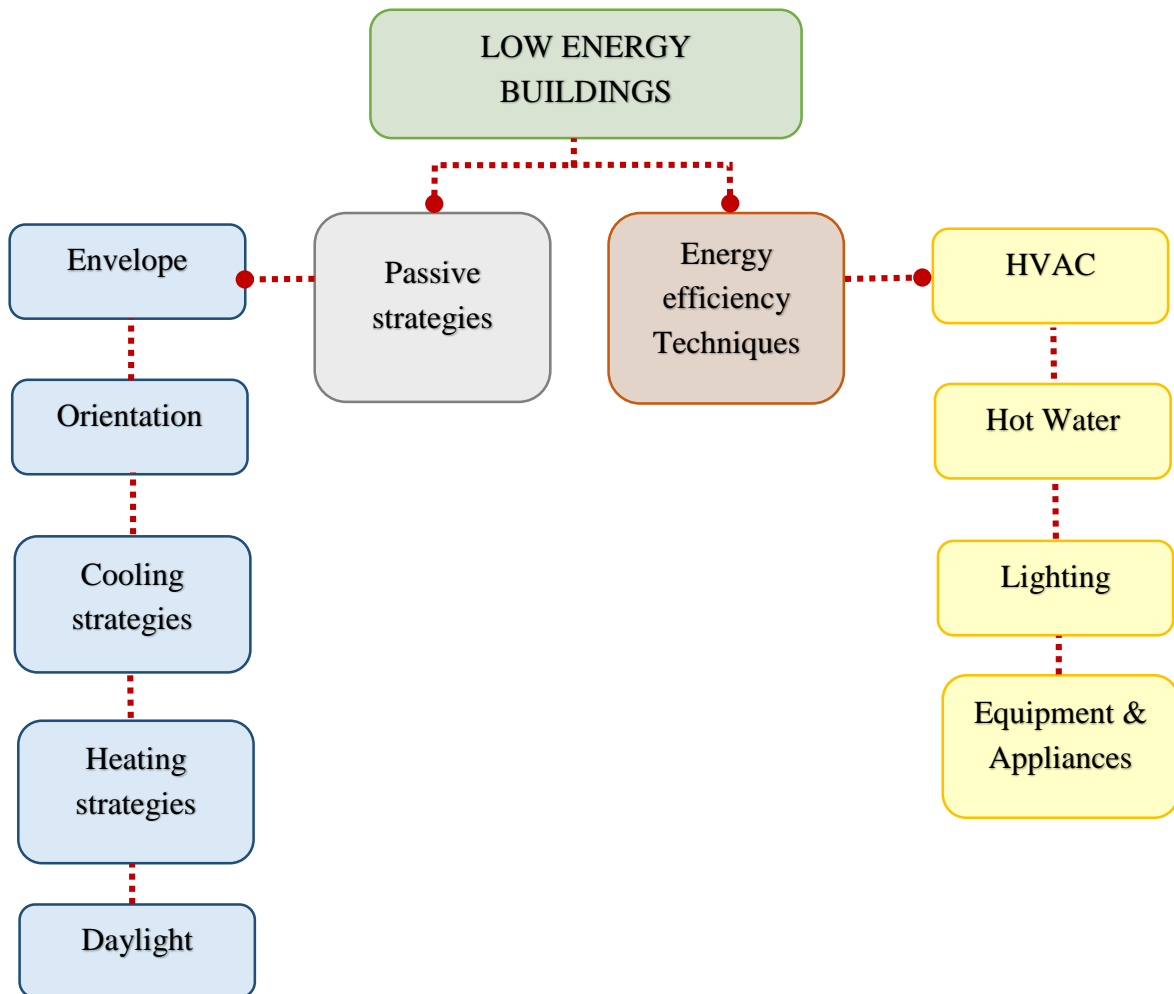
diagram 6: the link between energy efficiency techniques and passive strategies or a low energy building source: Rodriguez-Ubinas

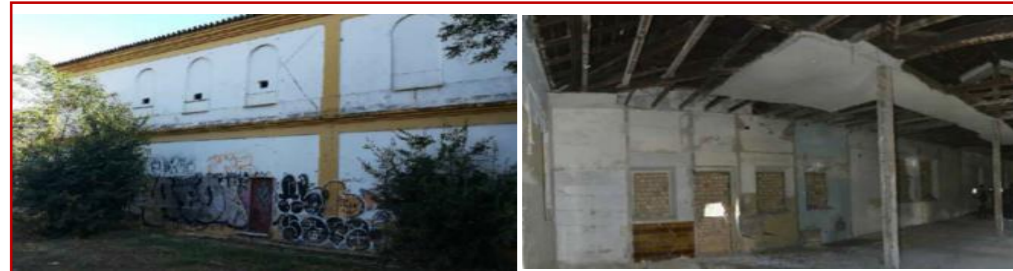
Figure 22: current-state pictures and section, source : creativecommons.org

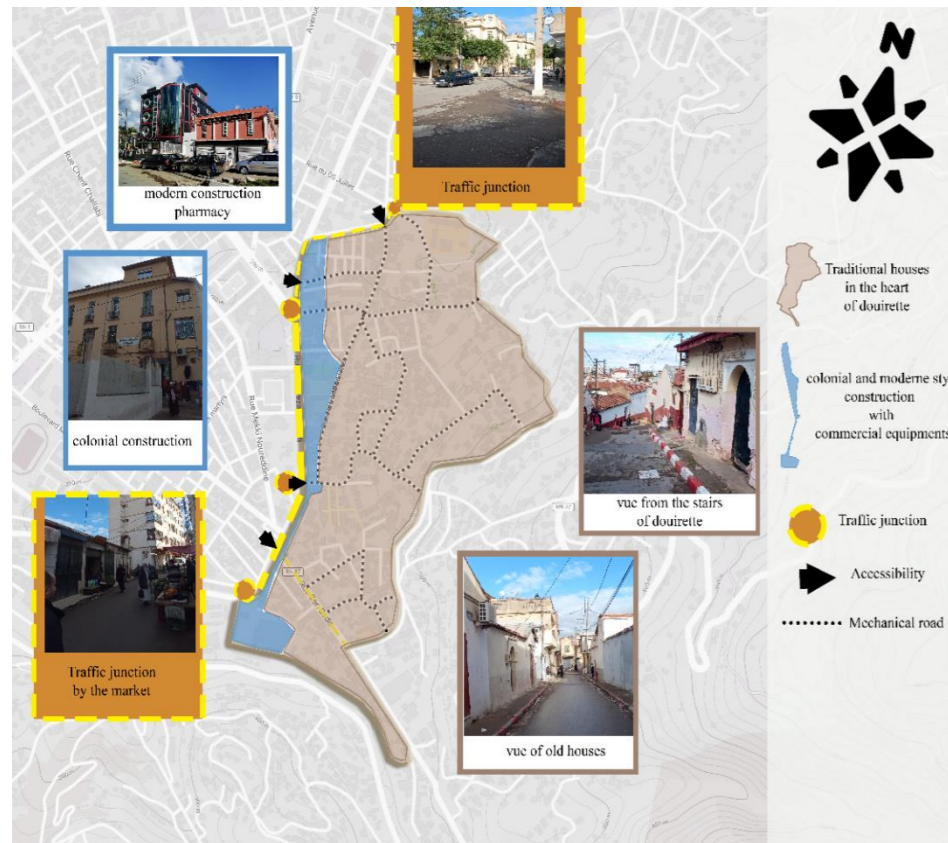
Figure 51: Hidden heritage by a mask of colonial houses & commerce source: mapcarta, edited by the author, photos taken by the author.

- In the figure above we can observe that much like how colonial architecture once covered the casbah with its grand facade, the lower portion of Douirette in Blida features an interesting blend of modern and colonial styles, all of which have been repurposed for commercial use. Meanwhile, the true essence of Douirette lies in its highest point, where the famous stairs ascend towards Chrea.

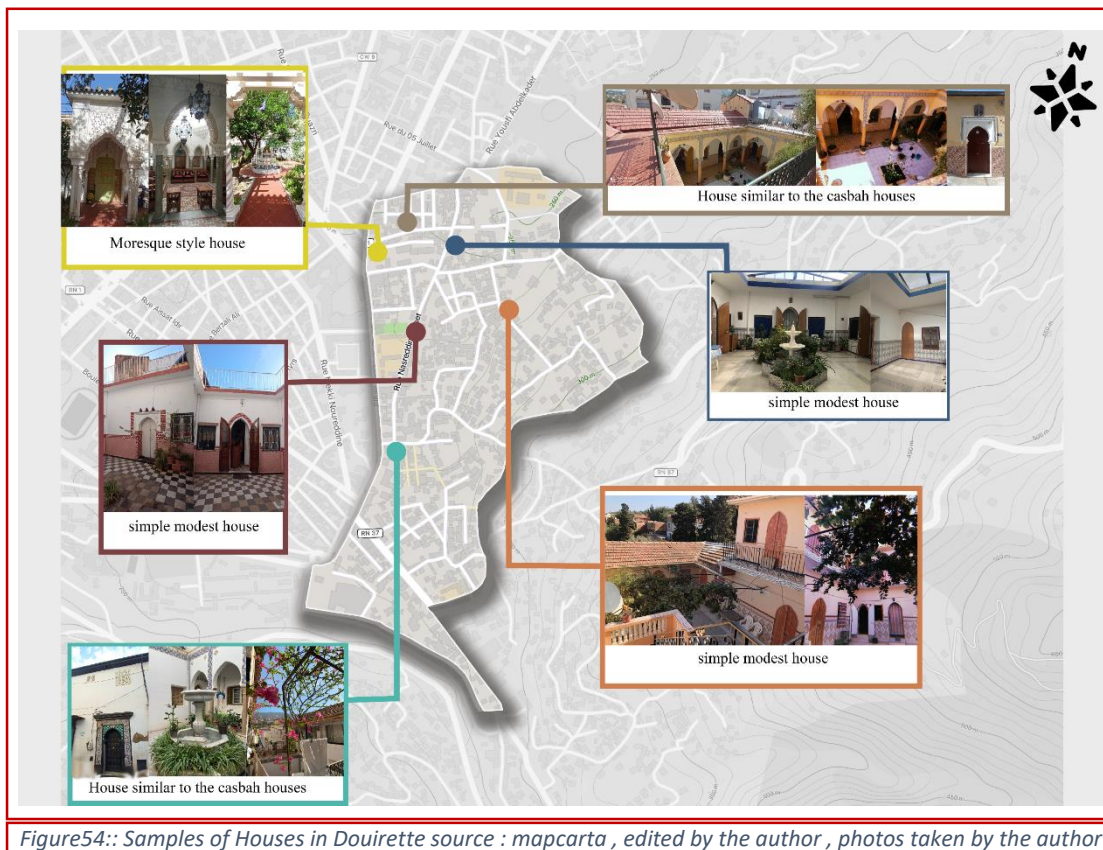
Figure54:: Samples of Houses in Douirette source : mapcarta , edited by the author , photos taken by the author

Blida has a rich cultural history, shaped by the influence of its local citizens, Moresque and Ottoman populations. In particular, Douirette's architecture reflects this diversity, resulting in a unique blend of styles that can be seen in its houses (see figure below). While some resemble the houses in the casbah, it's worth noting that the interior spatial distribution is the same in all Douirette houses. The common features shared with the casbah include a gallery on the patio, arched doors, and the same tiling on the walls and floor. This is the first type of house we noticed. The second type is simple and modest, featuring only a patio with the same spatial distribution but fewer decorations. Lastly, we observed a hybrid of the first two types, featuring a patio with no gallery but decorated with tile on the walls and floor, and all arched doors. The red-tiled roof, arched doors, and introverted nature with windows on the inside are common to all Douirette houses. Most are single-story with an attic room as an addition.

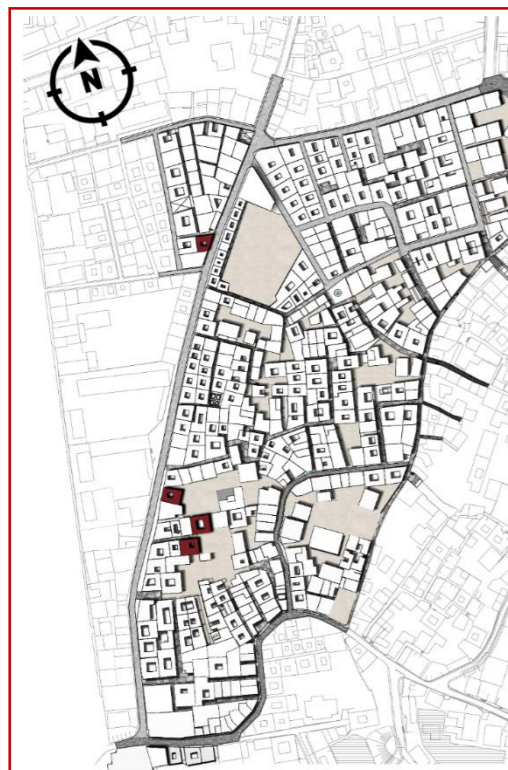
Figure 66: plan of the area of study that indicates the chosen houses, source : author

The last urban intervention that we will be undertaking is the energetic rehabilitation of historical houses. These houses, which are located on the road of Etienne Dinet, were carefully chosen after an educational outing with our teachers and a thorough inspection. Additionally, the local citizens played a crucial role in the decision-making process, making sure that the chosen houses aligned with our needs and preferences.

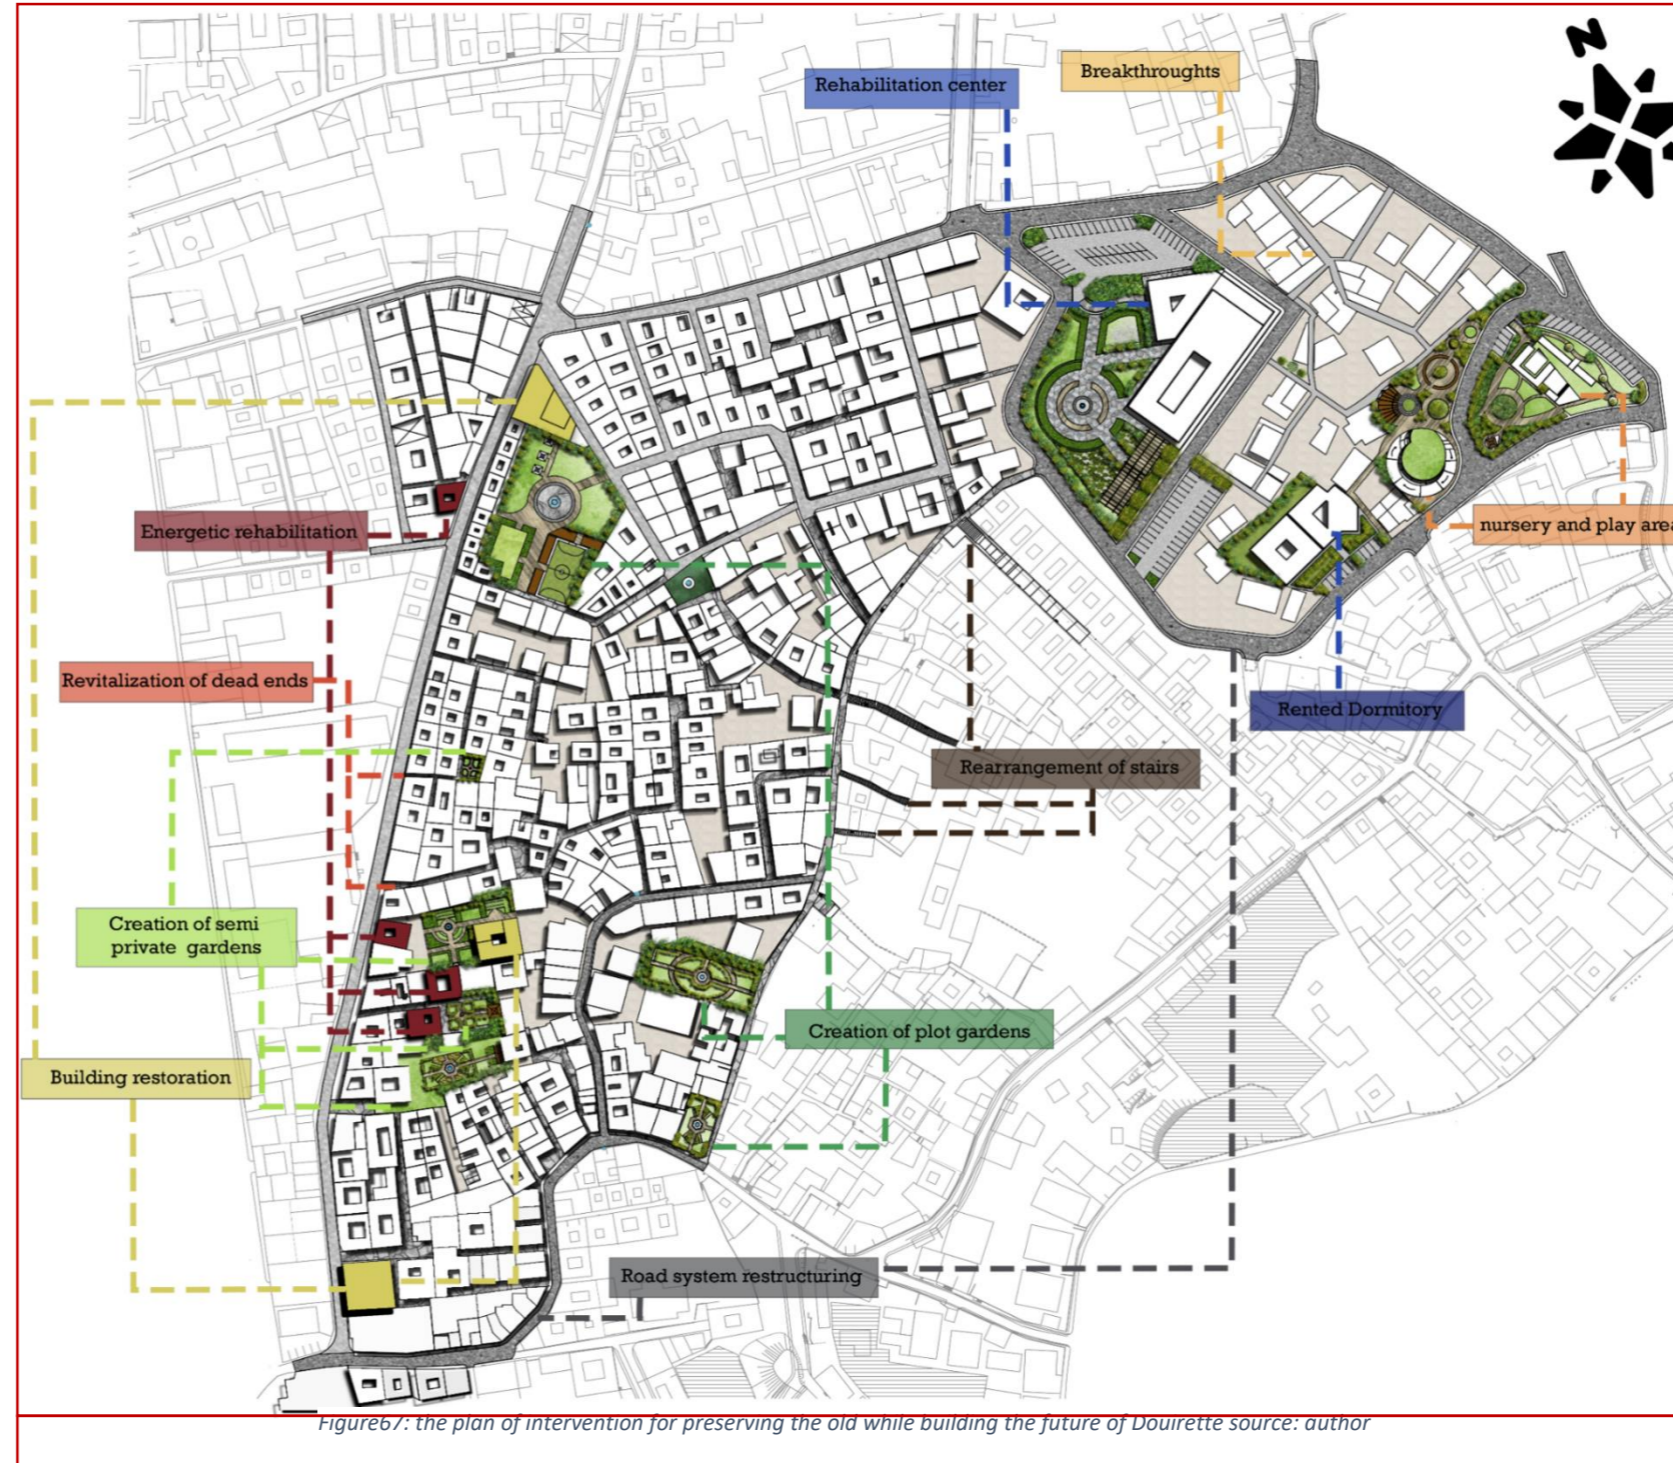
Figure 67: the plan of intervention for preserving the old while building the future of Douirette source: author

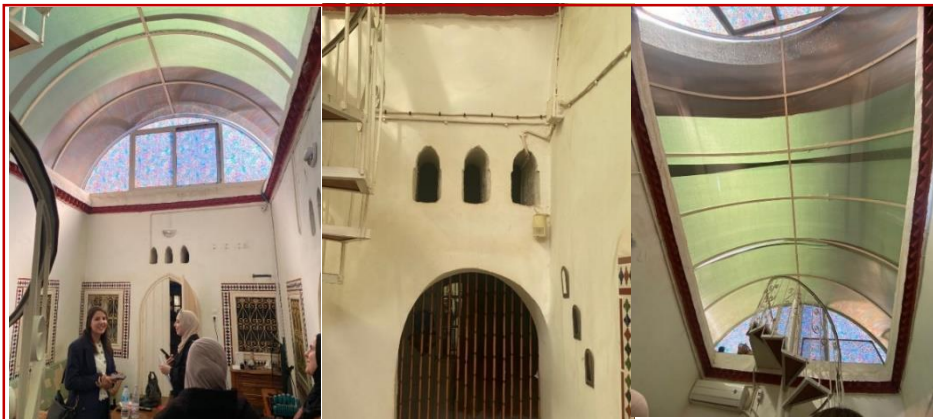
To sum up, House A.1 It is a monument to Douirette's architectural skill and cultural legacy, setting a high standard for other buildings to follow, this particular house was picked because of the improvement that took place in covering the previously open patio, which made the home more comfortable and required less energy, additionally, the owner was very cooperative and helpful [see figure 81], there is more to House A.1 than just a residence, an ideal combination of traditional construction and contemporary comforts [see figure 81]. It is a monument to Douirette's architectural skill and cultural legacy, setting an example for other traditional buildings to follow.

Figure 70: the first visit to the house, source: the author

Figure 71: the contrast between traditional construction and the innovation, source author

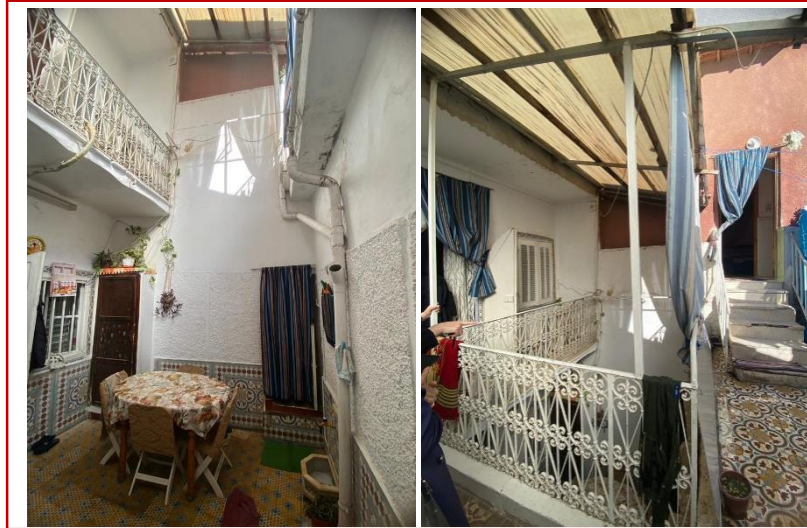
Figure 76: the ground floor and the first next to the extension and the patio renovation source the author,

Furthermore, the renovation process has included the patio, which is an essential part of traditional homes for natural light and ventilation. The unforeseen coverage further disturbs the energy behavior of the house because the patio is essential to preserving the microclimate within the house.

In conclusion, despite House B.1's important role in Douirette's past and community, unforeseen renovations are endangering its legacy. These modifications affect the house's energy efficiency and comfort levels in addition to disturbing the architectural harmony of the building. It serves as a reminder of how crucial it is to carefully plan renovations of historic buildings while also honoring traditional building techniques.

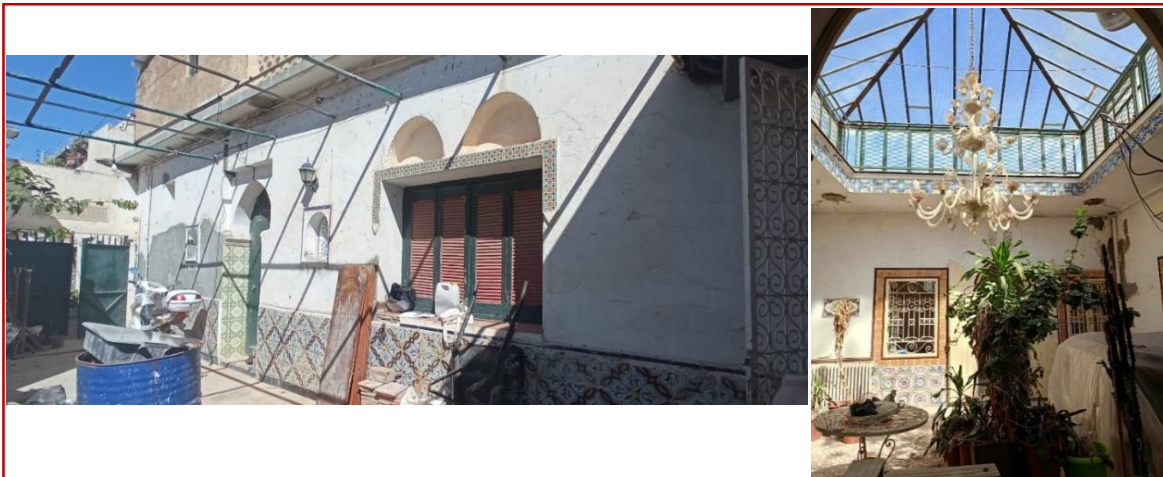
The bustling house, home to a family of six, is undergoing repairs. Despite its historical and architectural value, the oldest house is showing signs of deterioration. A major issue is the closed-off patio, disrupting the house's microclimate. Previously, the patio allowed natural light and ventilation, but this modification is now impacting comfort levels and speeding the house's deterioration.

Figure 79: the main entrance through impasse Younes, source: the author

Figure 80: the patio of the house, source: author

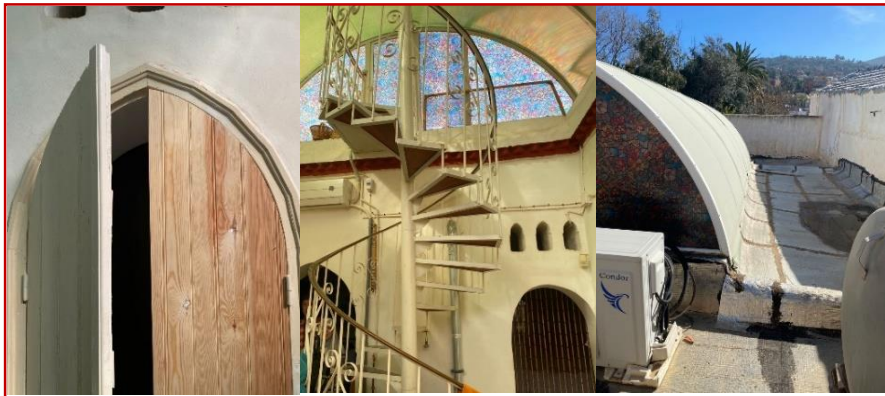
Figure82: the changes that accrued in the house , source author

A spiral staircase was added to provide access to the terrace and a unique architectural feature to the house. The wooden bedroom doors were rebuilt to replicate the original design while retaining the traditional aesthetic appeal, significant repairs were done to fix the roof's waterproofing. This was a crucial intervention that not only protected the house from water damage but also enhanced the longevity of the structure.

Lastly, to ensure privacy and security, a window and two doors that used to connect the house to the neighbors were closed off. This change helped to define the boundary of the house and ensure the privacy of the residents. In conclusion, these interventions, while necessary, ensure that changes meet current needs without damaging the historical and architectural integrity of the property.

- The construction details involve the use of a bearing wall with adobe brick, floor joists, and wooden battens for structural support, the construction will be detailed in the technical diagnosis.
- The characteristic elements of the patio, tiled floors, window tiles, and elegantly arched doors.

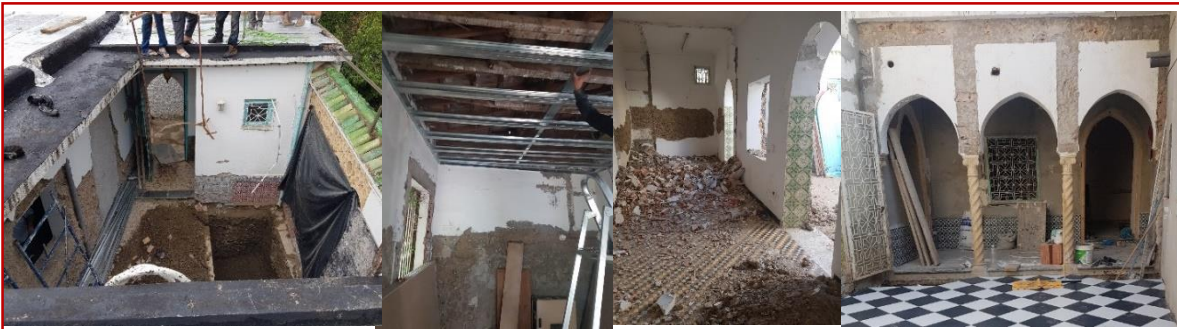
Figure 88: the different interventions that were done in the house, source: the owner of the house

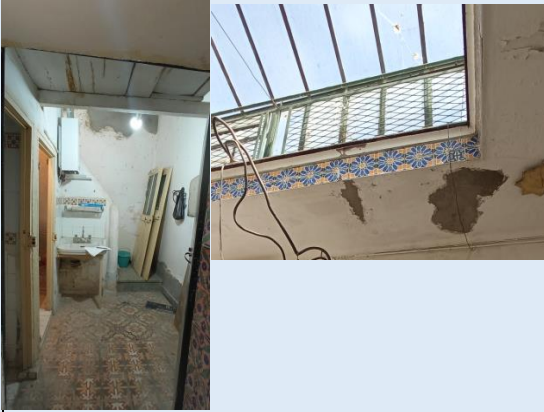
Roof, openings, and the patio glass	The patio glass is severely cracked and fragile. The window glass shows signs of damage. The roof appears significantly damaged, likely due to external factors.

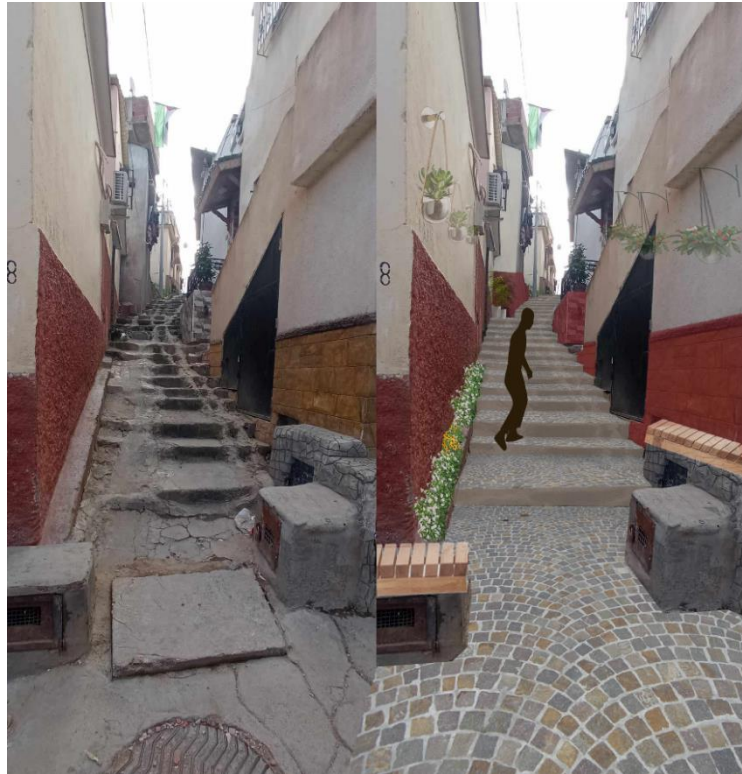
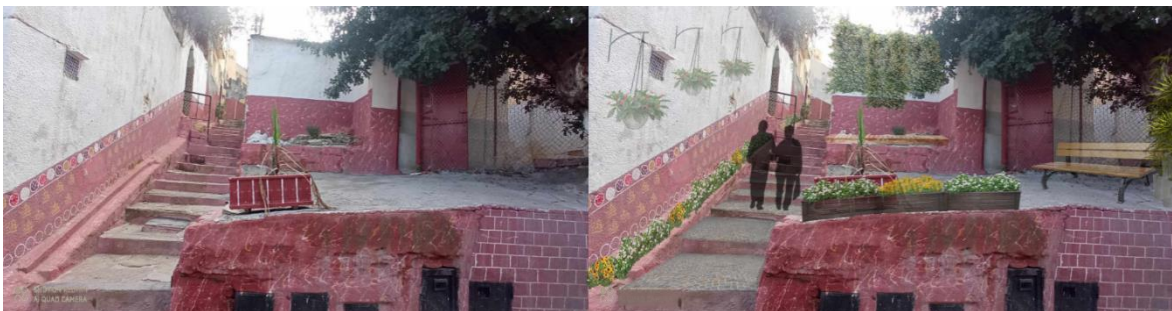
- The urban intervention in Douirette focuses on several aspects to improve the ease of movement and relaxation in the area. One of these details involves the reconstruction of the stairs, which will be repainted using vibrant local colors. To further enhance the aesthetic appeal and functionality, more local vegetation will be added, and seating chairs made of wood and steel will be introduced as well the two figures below show the actual state and after the changes proposed.

the before and after of the local stairs in Douirette, source author

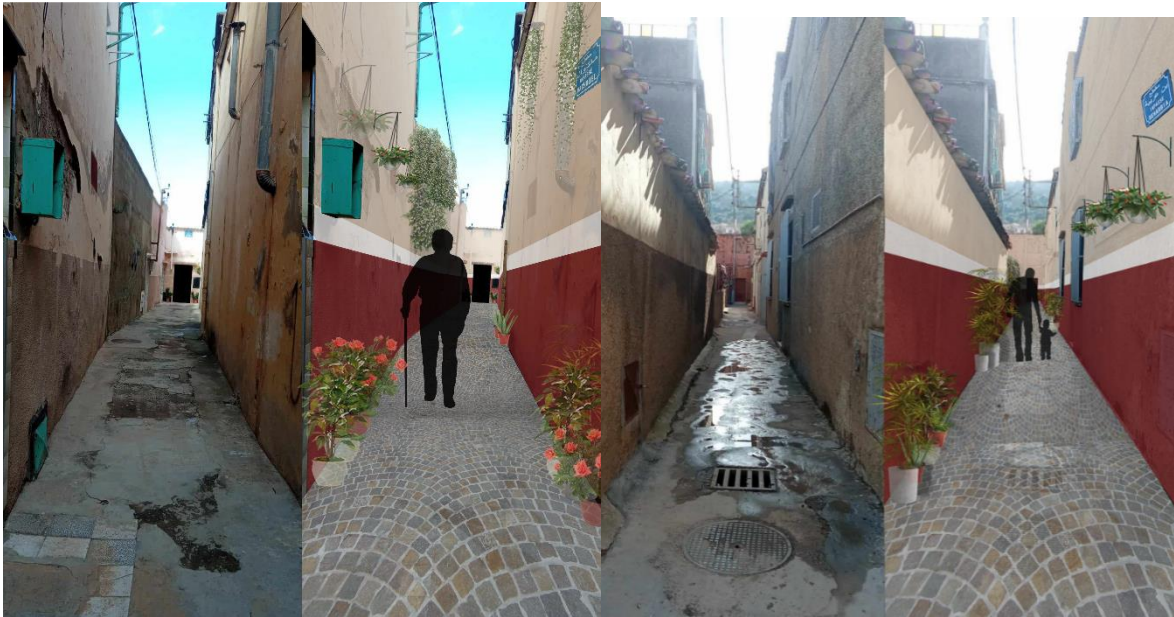
- As mentioned earlier, the primary goal of The Urban intervention is to make it easier for people to move around and find relaxation within the designated area. One of the details is focused on the revitalization of dead ends that lead to the houses. These dead ends will be repainted using vibrant local colors, similar to the methods used before. Additionally, we will be changing the floor to further enhance the aesthetic appeal and functionality. Moreover, adding more local vegetation to the walls to create a more vibrant and beautiful environment see figure below or the before and after in the two dead ends.

the before and after of the local stairs in Douirette, source author
